# STRUCTURAL ASSESSMENT REPORT

## **WASHINGTON PARK NATIONAL BANK**

6300 South Cottage Grove Ave.  
Chicago, Illinois 60637

**RE:** Structural Assessment Report for  
**Washington Park National Bank Building**  
6300 S. Cottage Grove  
Chicago, Illinois, 60637  
Probe Project No: 2018.529

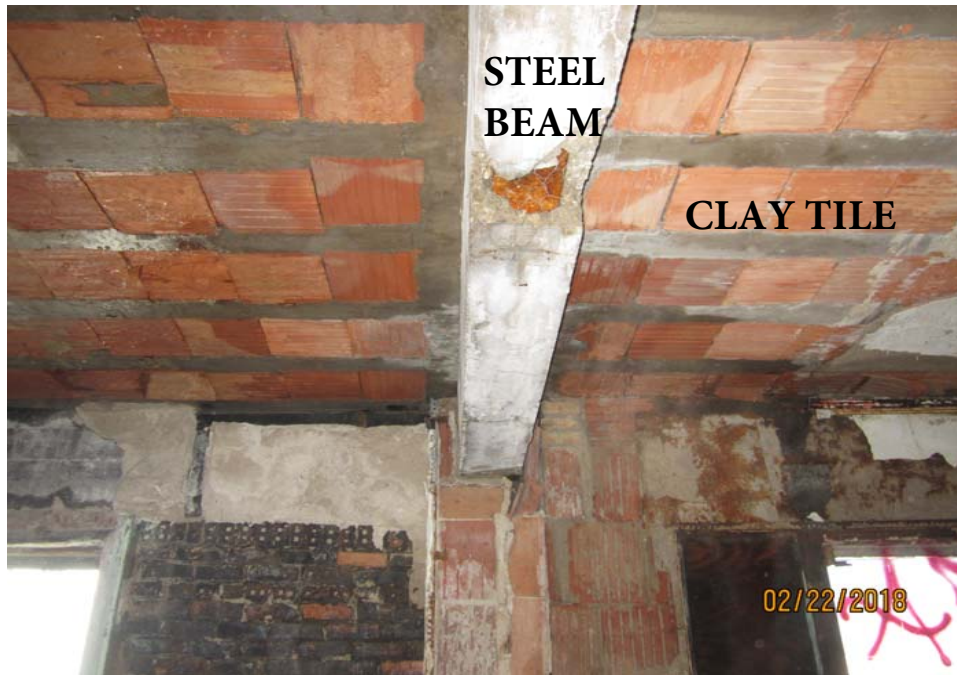
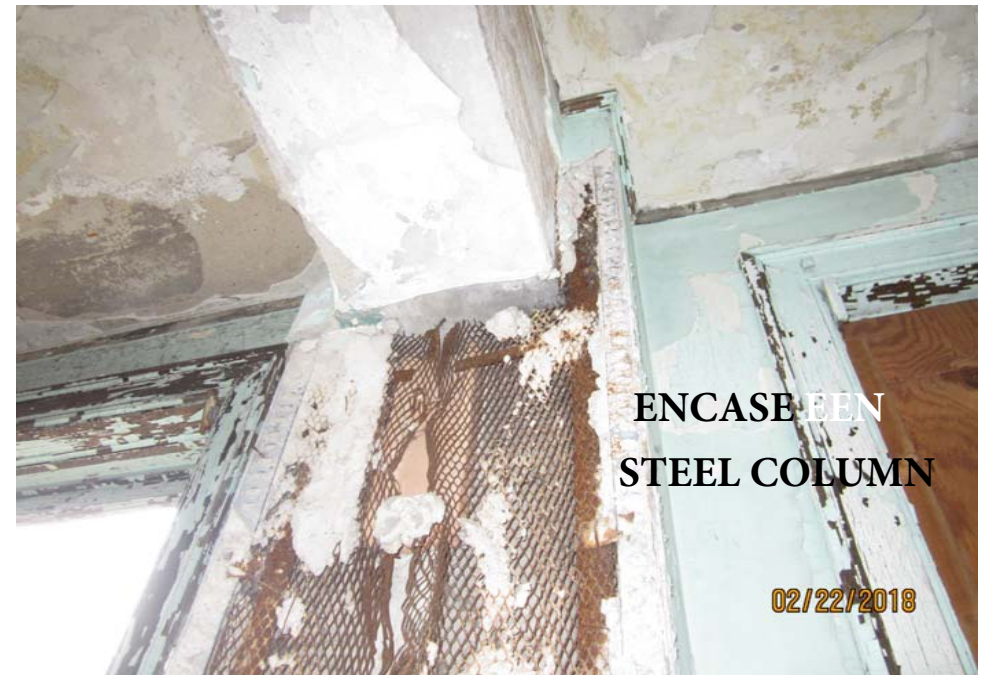
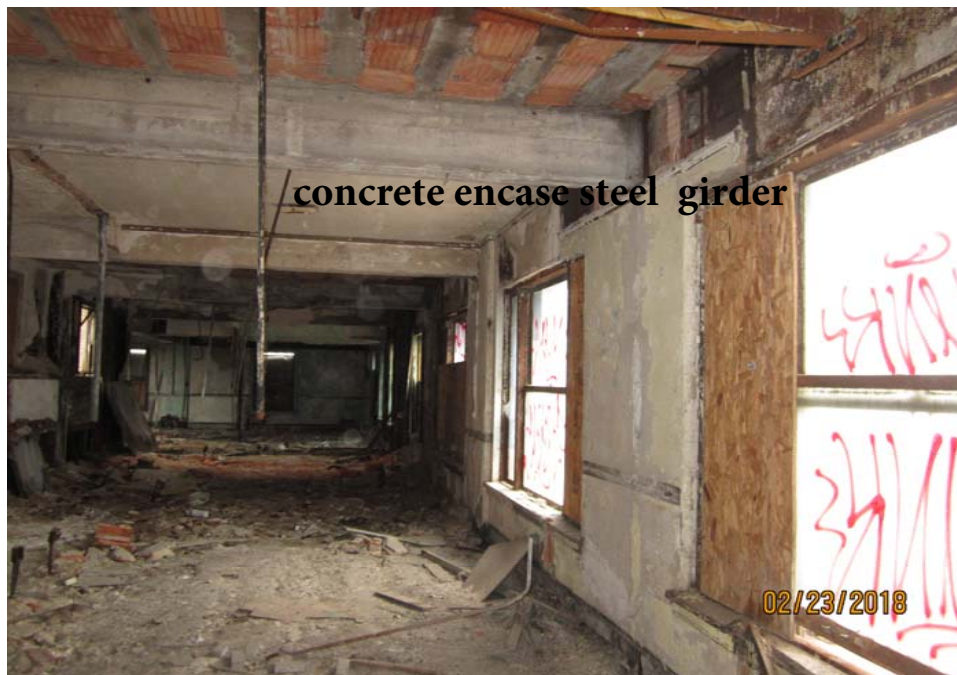
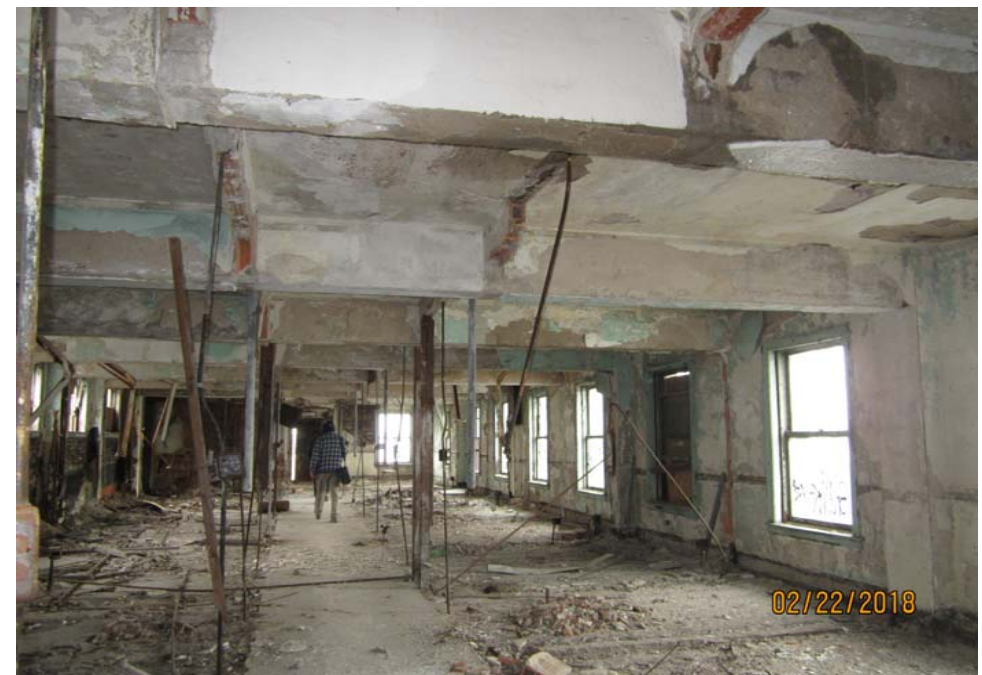
TYPICAL STRUCTURAL COMPOSITE CONCRETE CLAY-TILE FLOOR , Note concrete encased steel beams and columns . Underside of floors in good condition. View at the underside of 3r, 4th floors and roof. Page 3

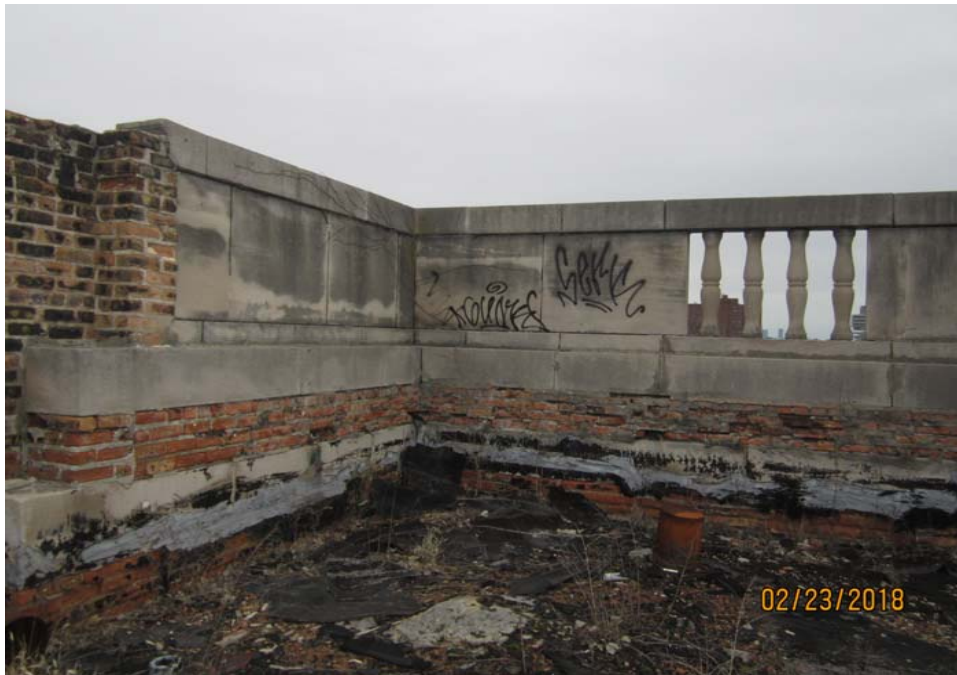
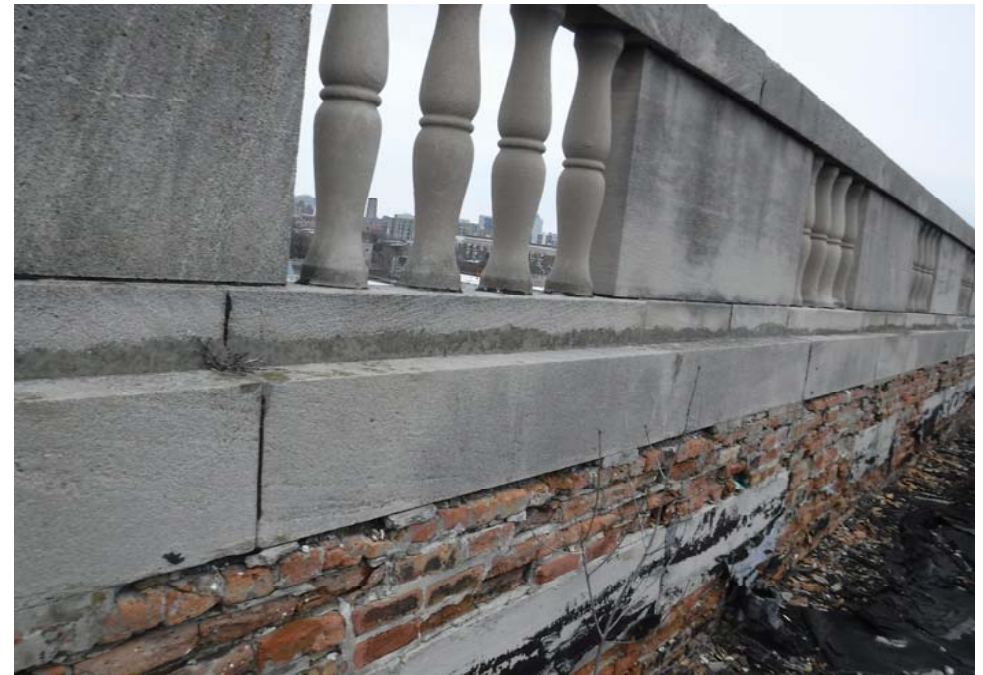
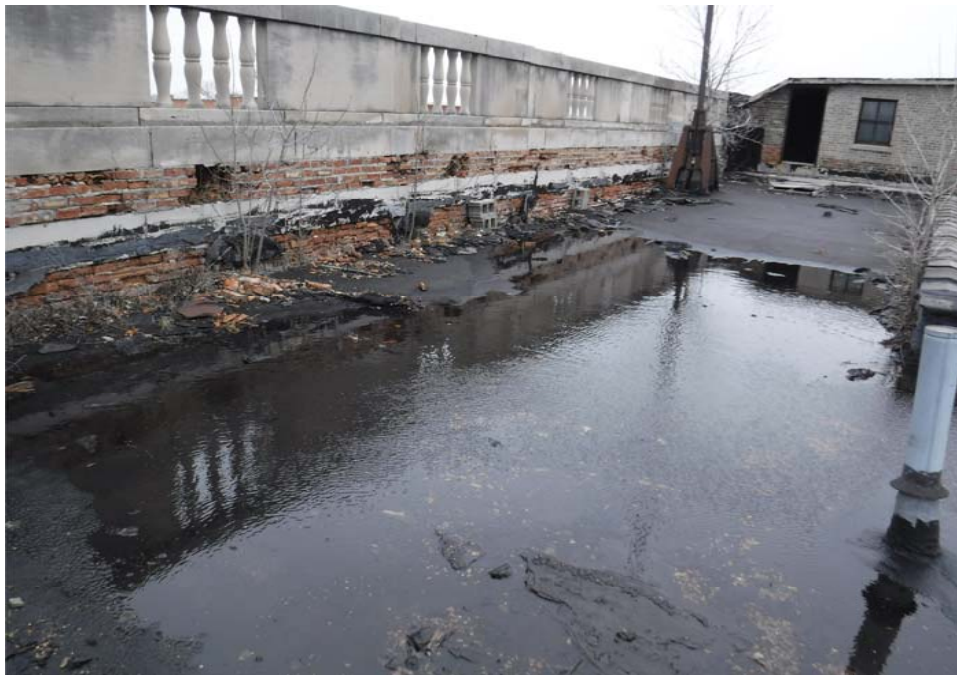
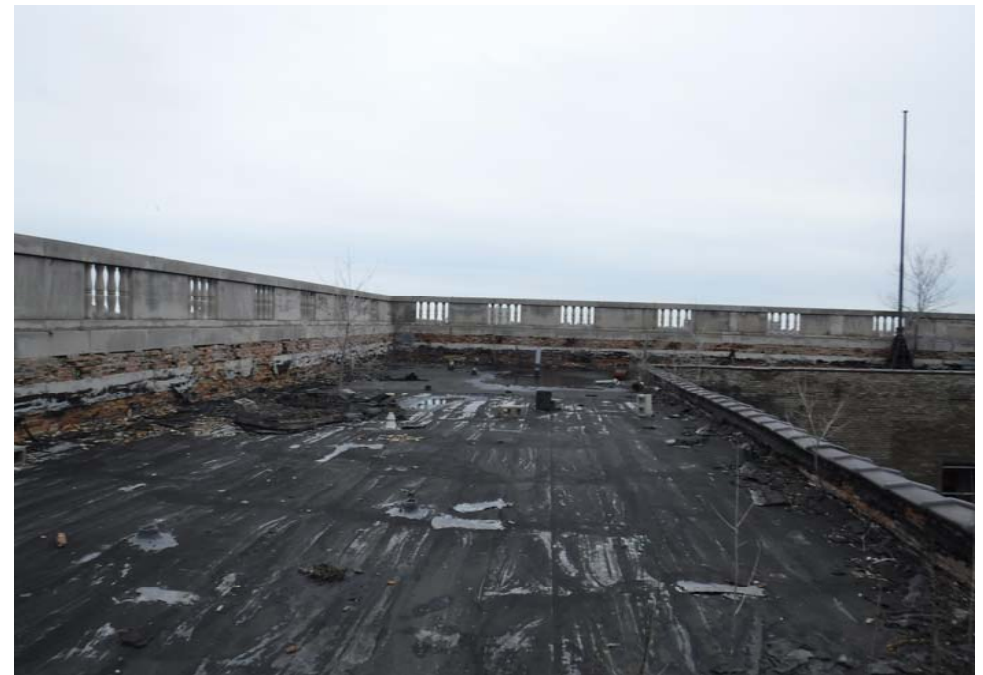
The building roof was in a poor condition with water puddles especially in the northern portion of the building. Vegetation and plant growth were observed along the edge of parapets,

The tall roof top parapets are composed of brickwork supporting the limestone cornice and balusters and balustrades. The parapets exhibited moderate damage in the form of open mortar joints, loose brickwork, and plant growth. The limestone elements showed some displacements and open and deteriorated joints.

ROOF TOP V: Note ponding and deteriorated brickwork and limestone parapets.

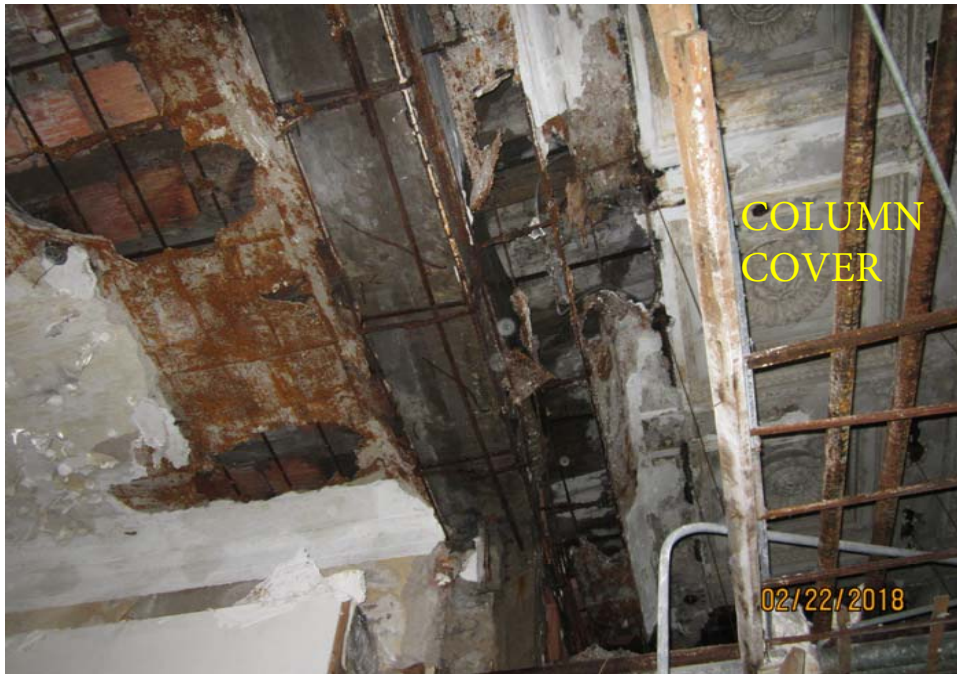
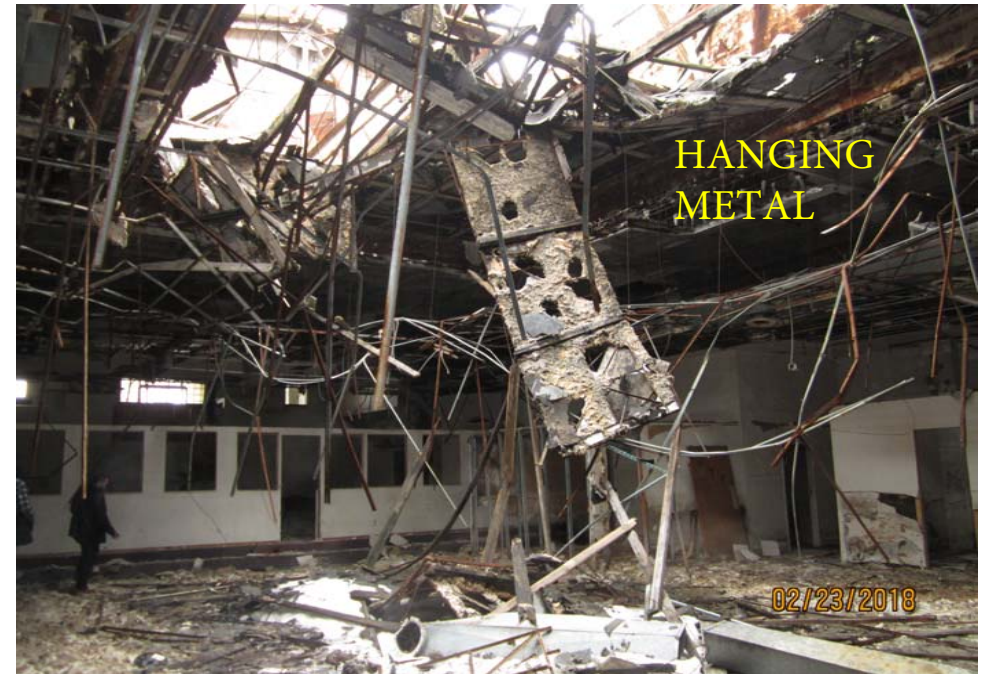
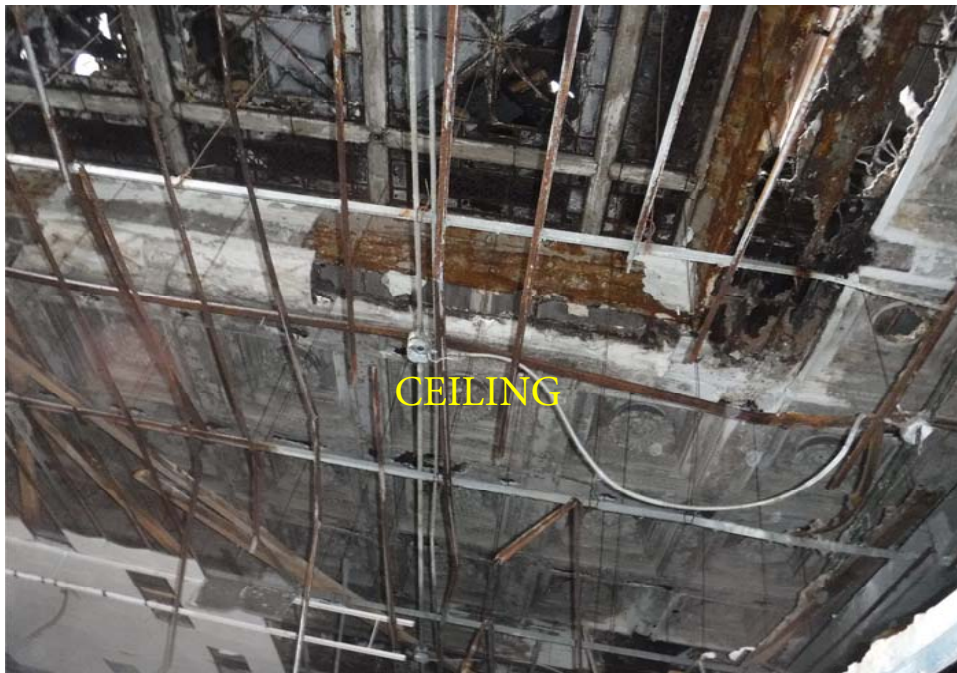
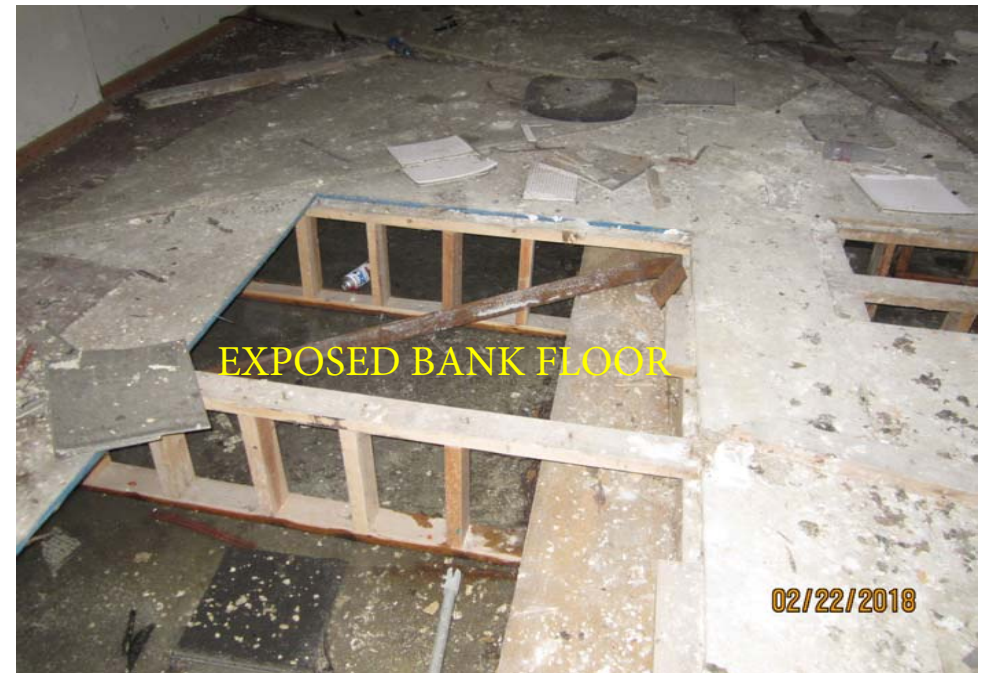
**A.1 Existing Conditions:** The building was found to be total disrepair with vast amount of debris on the floors mainly on the 2<sup>nd</sup> floor. The debris was mainly composed of damaged and loose ceilings, partitions, wall and floor coverings, and broken fixtures. The windows were stripped and boarded on all floors. The atrium skylight roof framing had totally collapsed with debris lying on the 2<sup>nd</sup> floor which was found to be unsafe for inspections. The first floor and 3<sup>rd</sup> and the 4<sup>th</sup> office floors were in a little better condition for visual observations.

VIEWS OF THE MAIN ATRIUM FLOOR ( 2nd Floor), Note loose ceiling tiels, framing, and finishings. Page 5

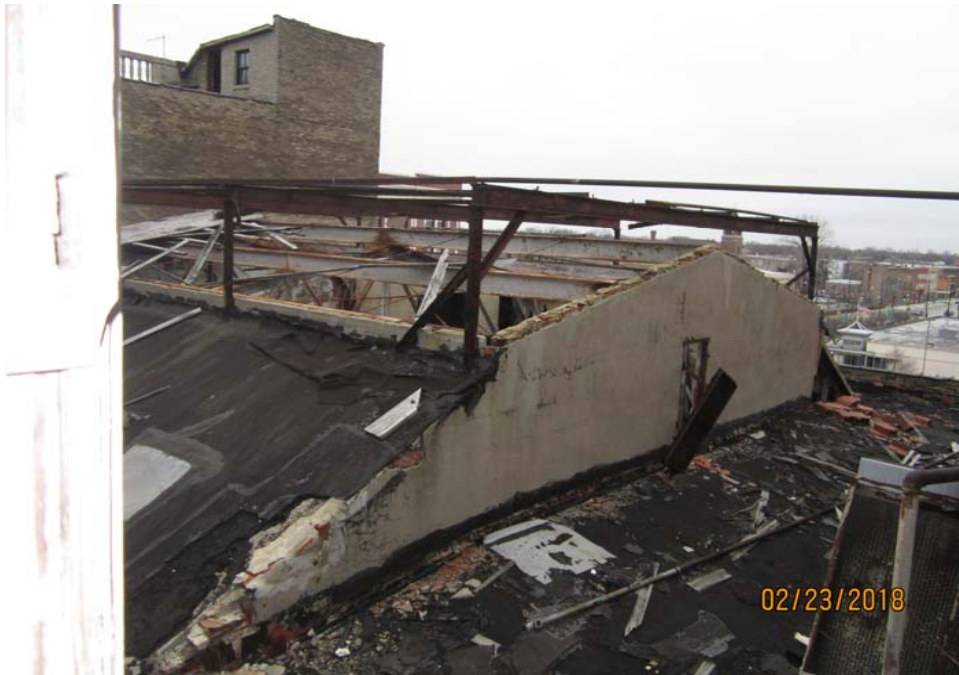
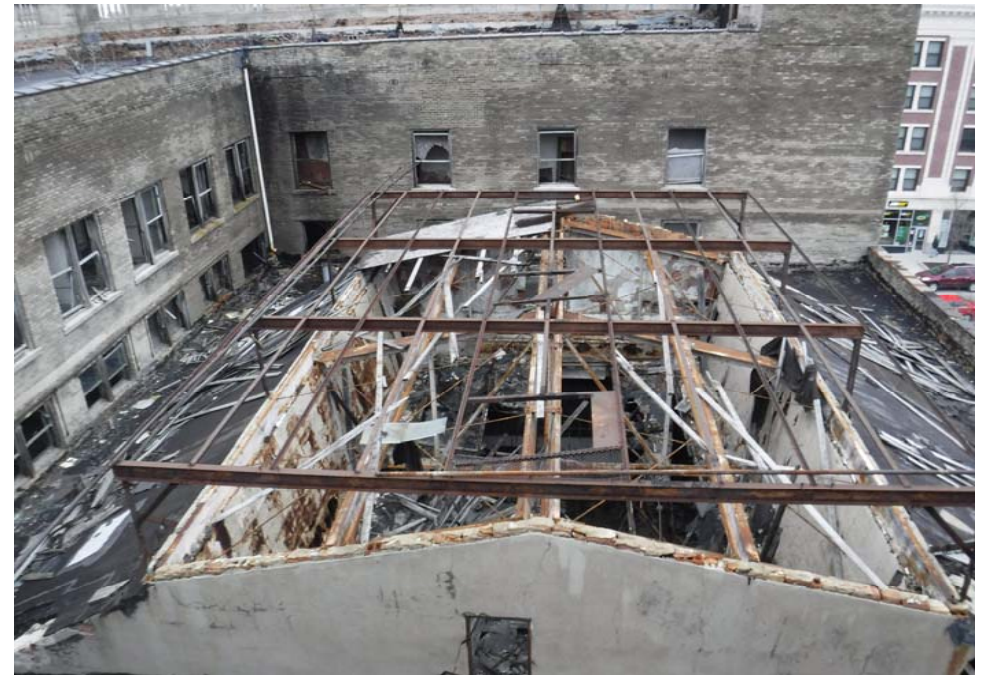
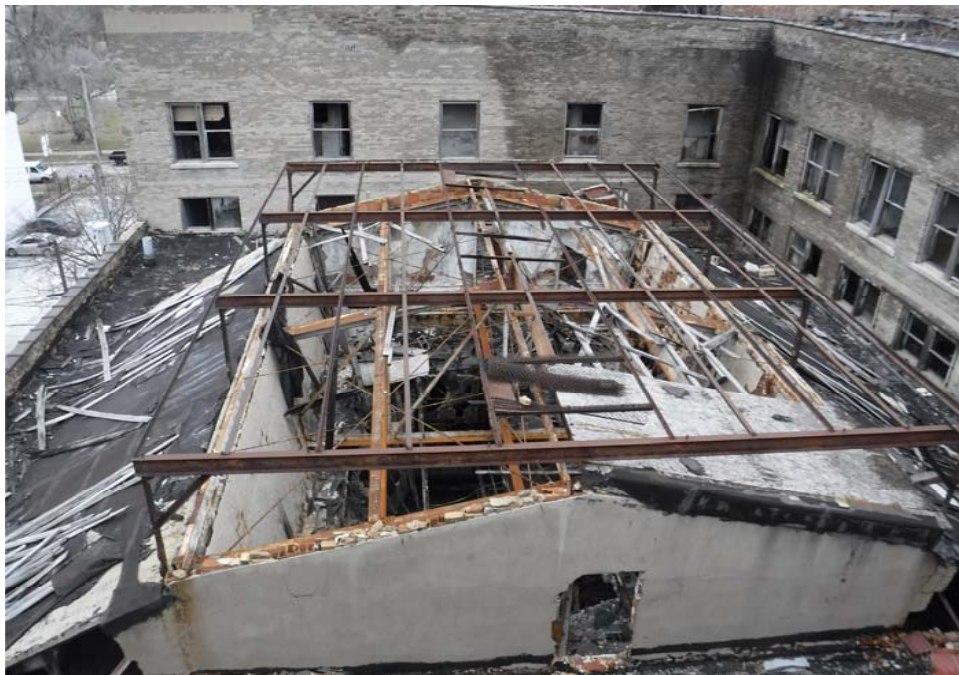
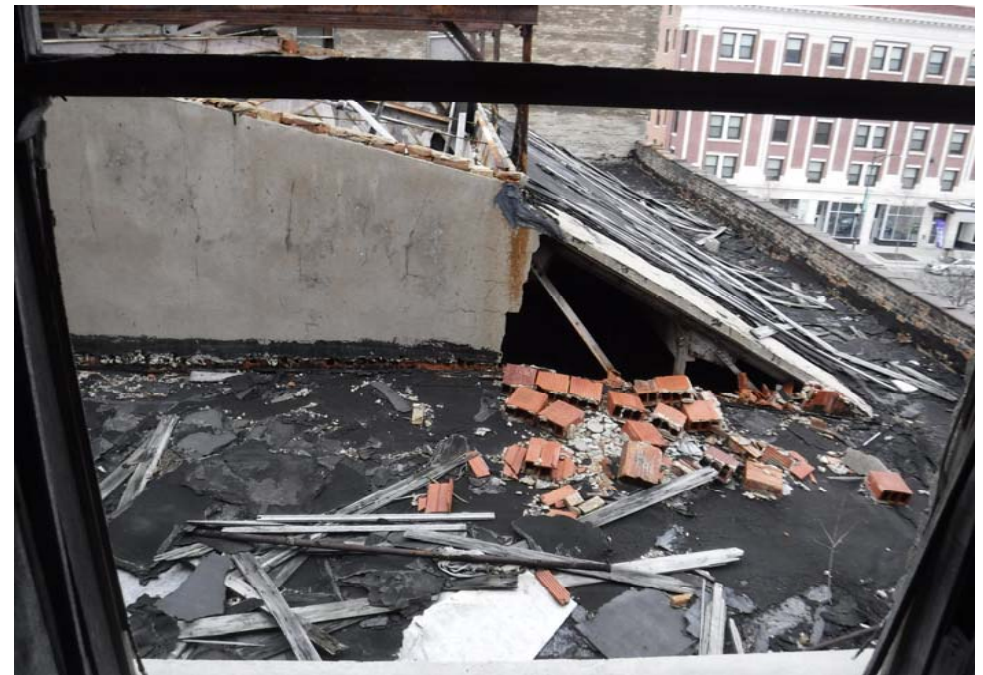
We did not see any visible signs of damage to the main structural framing system which is composed of beams, girders and columns. The under-side of the floors was found to be in good condition. Although, the atrium skylight framing roof had collapsed, it is considered secondary since it was supported by main structural framing of the building (mainly the 3<sup>rd</sup> floor). The main east and west concrete walls supporting the Atrium roof framing were still standing and intact.

ATRIUM CEILING FRAMING SUPPORTED BY 3rd FLOOR. Note loose secondary framing of atrium roof which not a part of main structural framing of the building. Main steel framing was not visible.

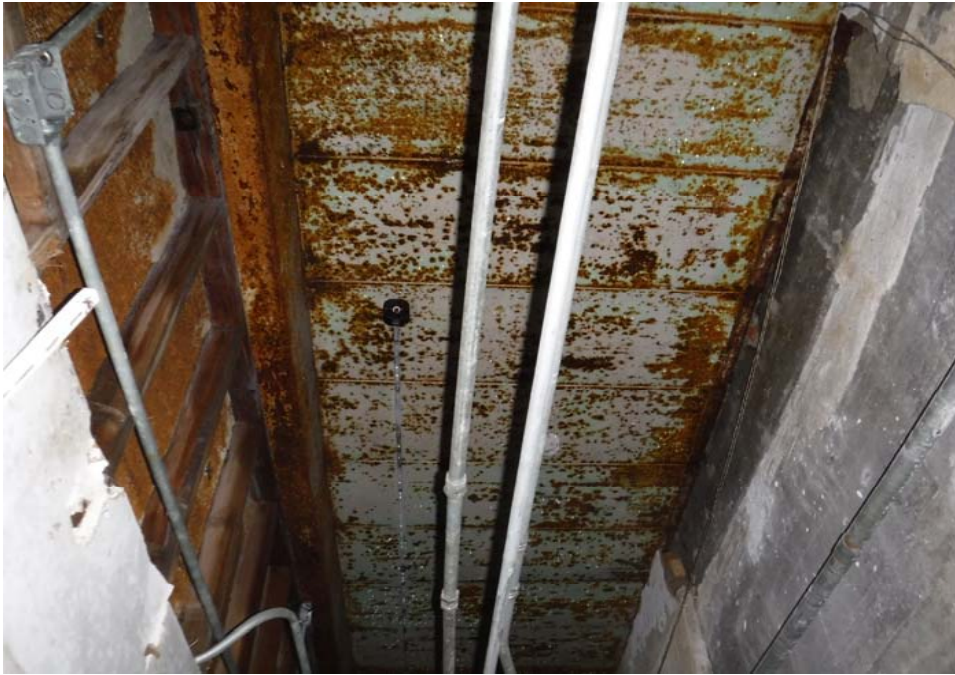
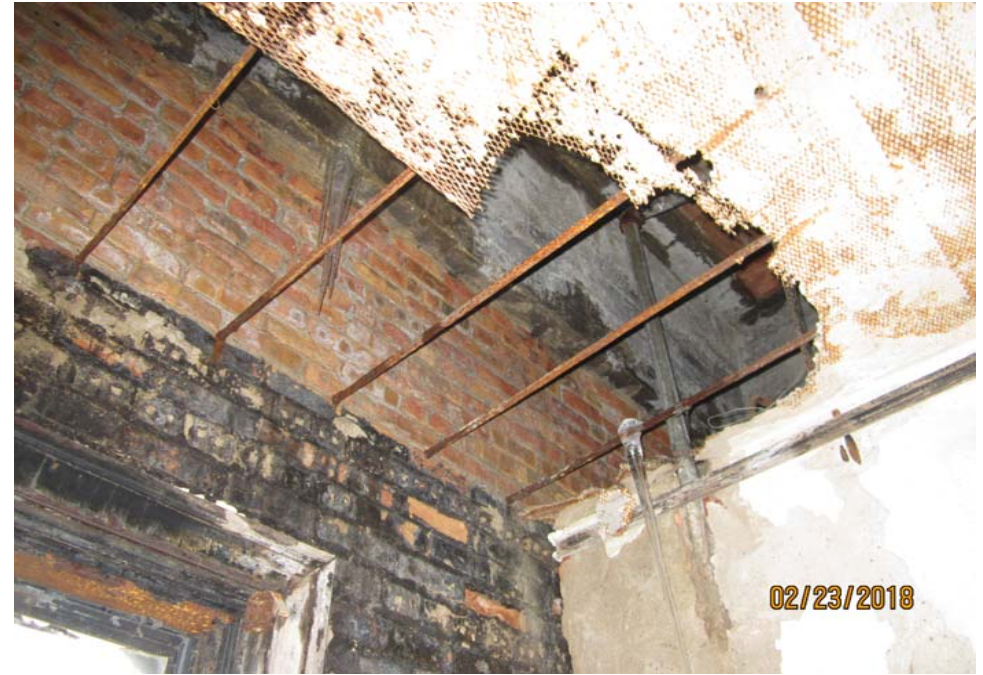
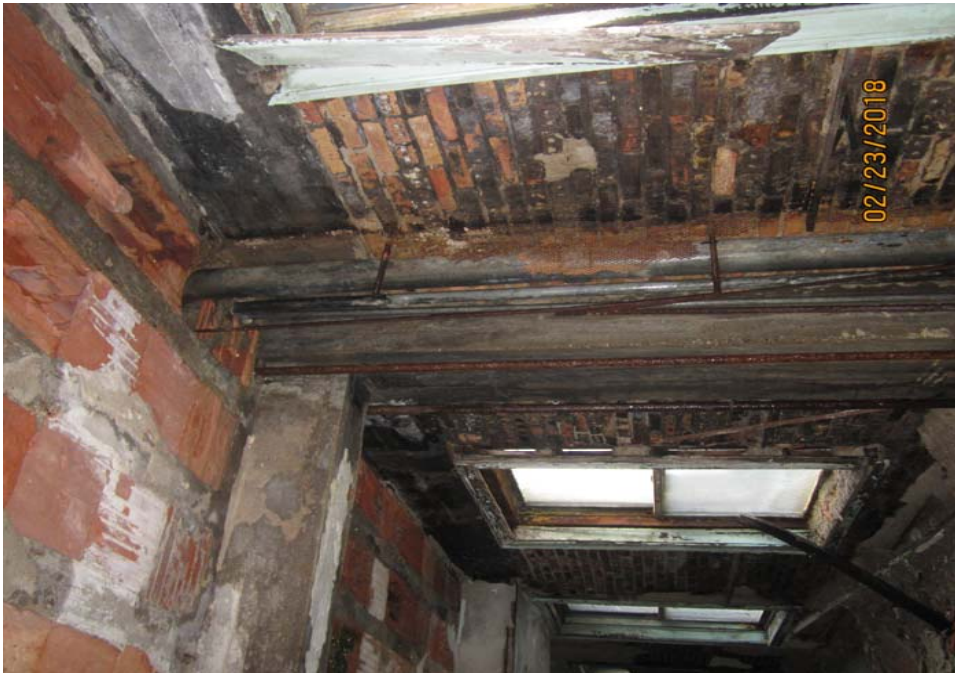
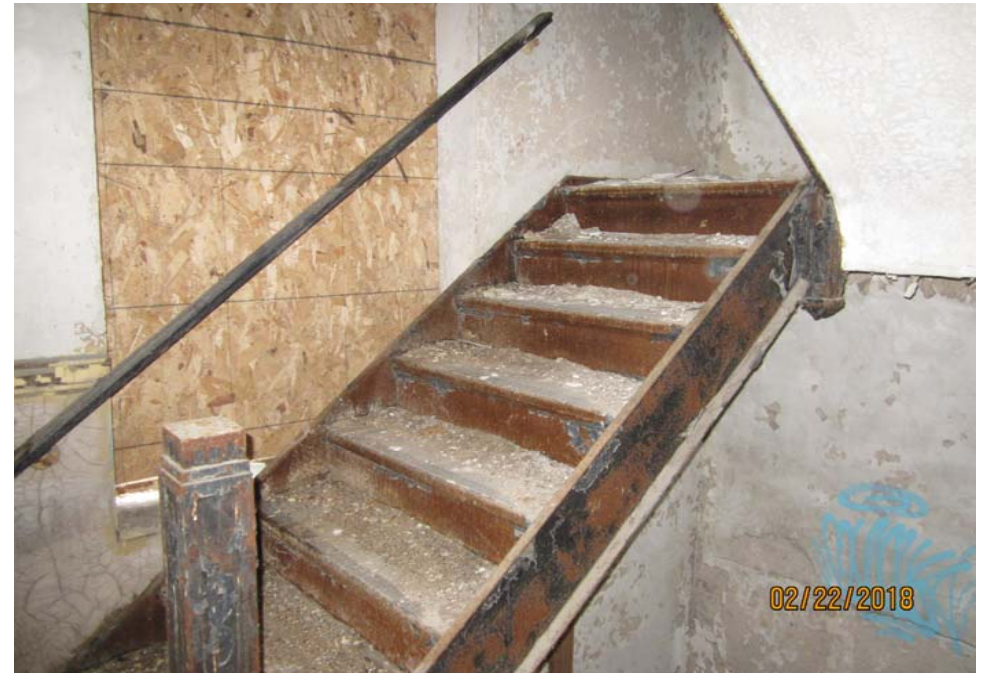
TYPICAL CONSTRUCTION DETAILS : Note interior facing of perimeter masonry walls, steel stairs, and perimeter concrete encased steel columns found to be in sound condition.

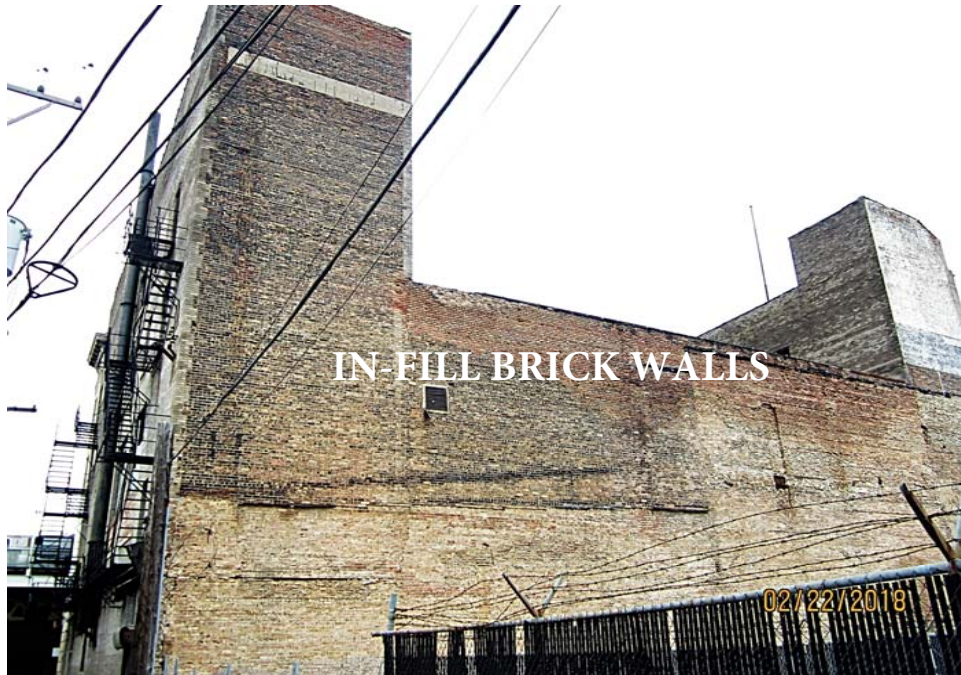
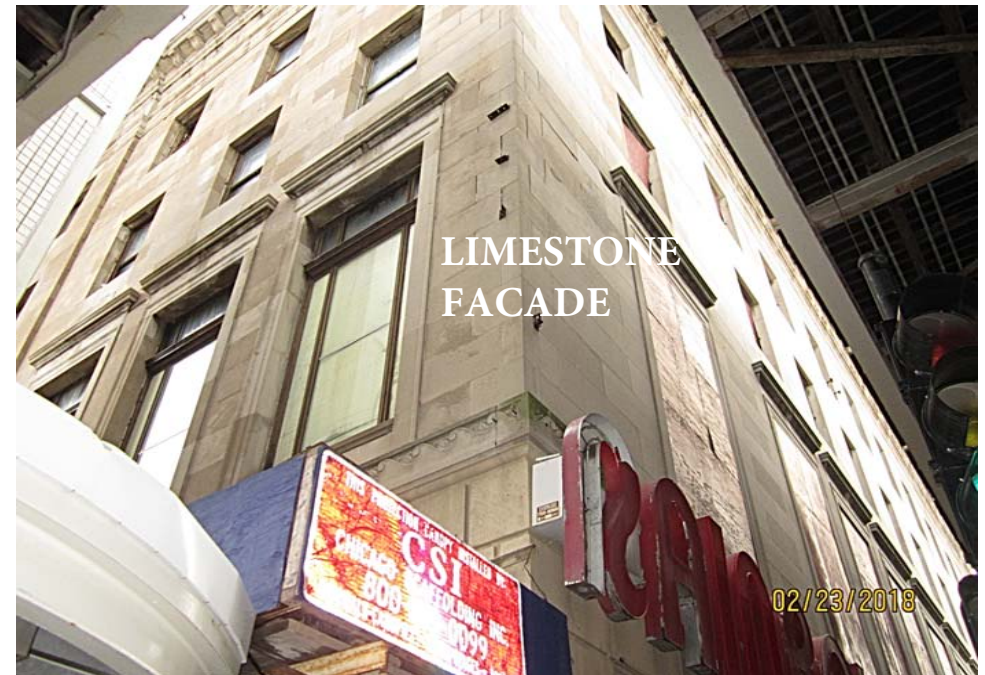
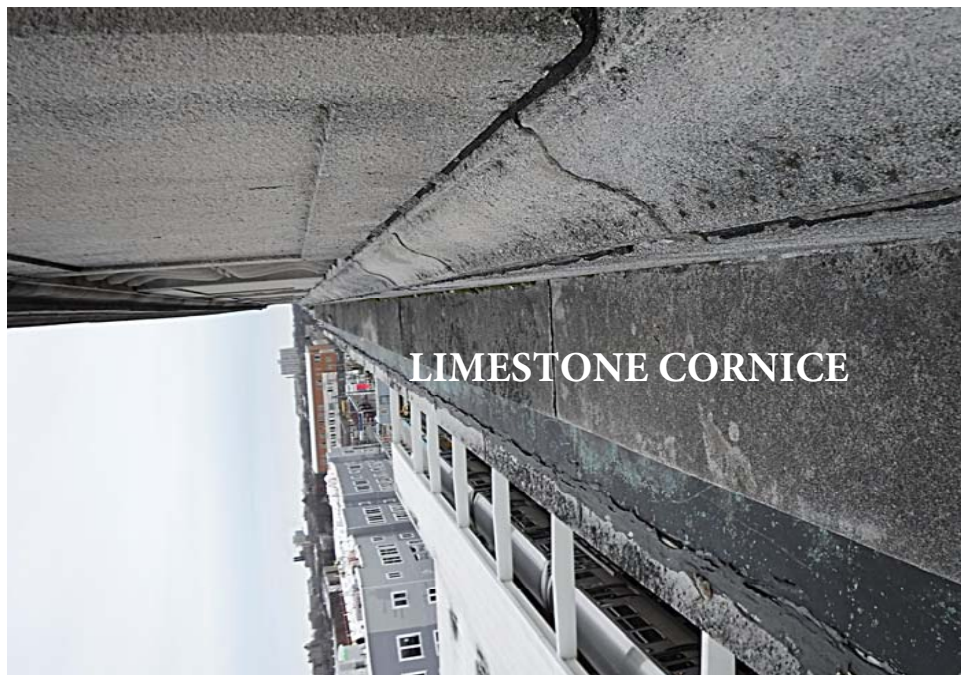
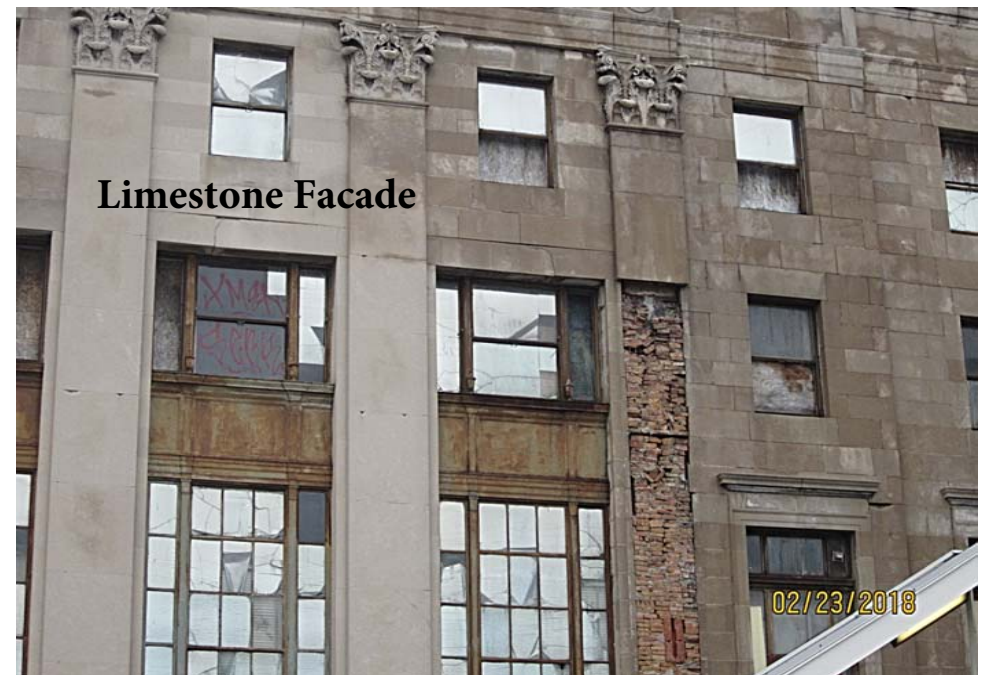
**A.4 Facades and Exterior walls and Parapets:** The building facades on the street fronts are composed of Bedford Limestone and were generally found to be in fair condition. A portion of limestone had previously fallen down on the Cottage Grove side. A street side canopy has been installed as a precautionary safety measure. The facades on west and south elevations include in-fill brick masonry walls supported by perimeter steel girders. The brick walls were found to be in fair condition with few signs of cracking and spalling.

**EXTERIOR WALLS WERE GENERALLY IN FAIR CONDITION. Exceptions include fallen limestone pieces and open mortar joints which should be repaired. Brick walls on south and west were OK.**

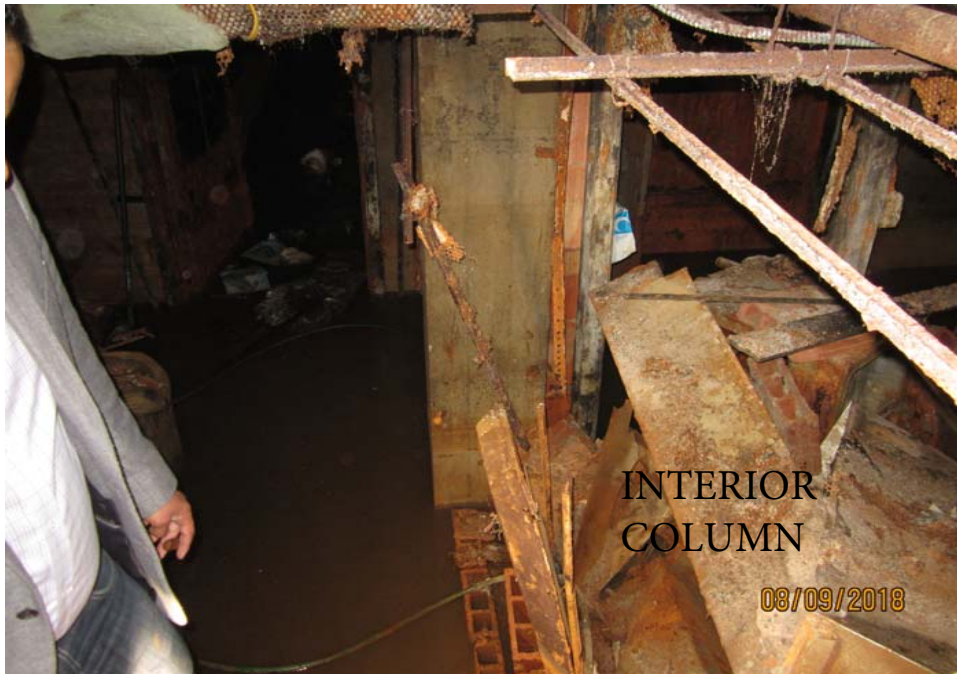
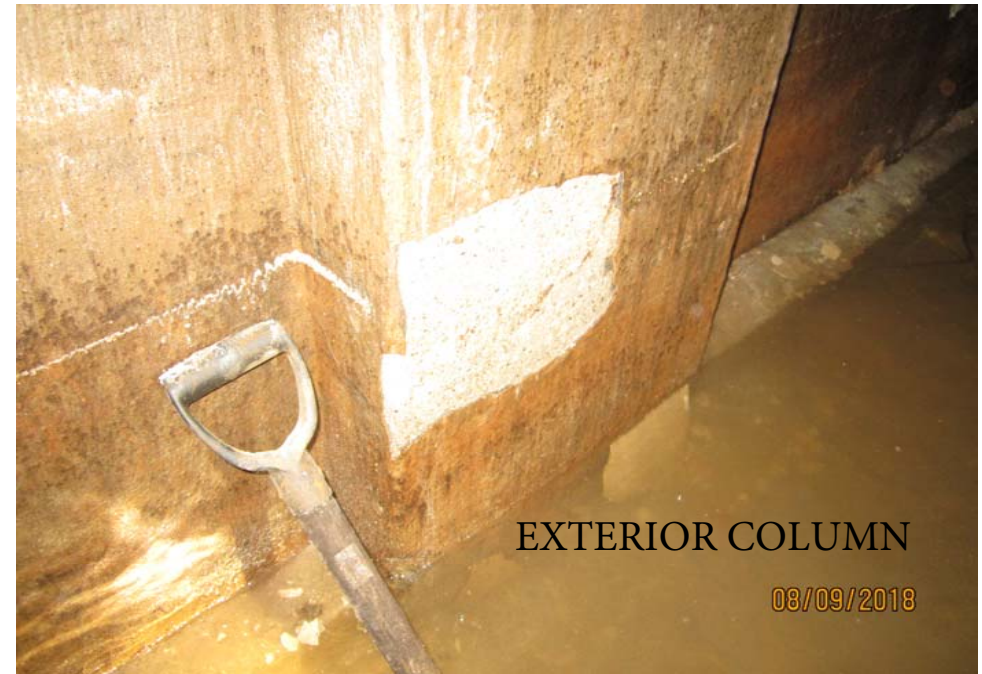
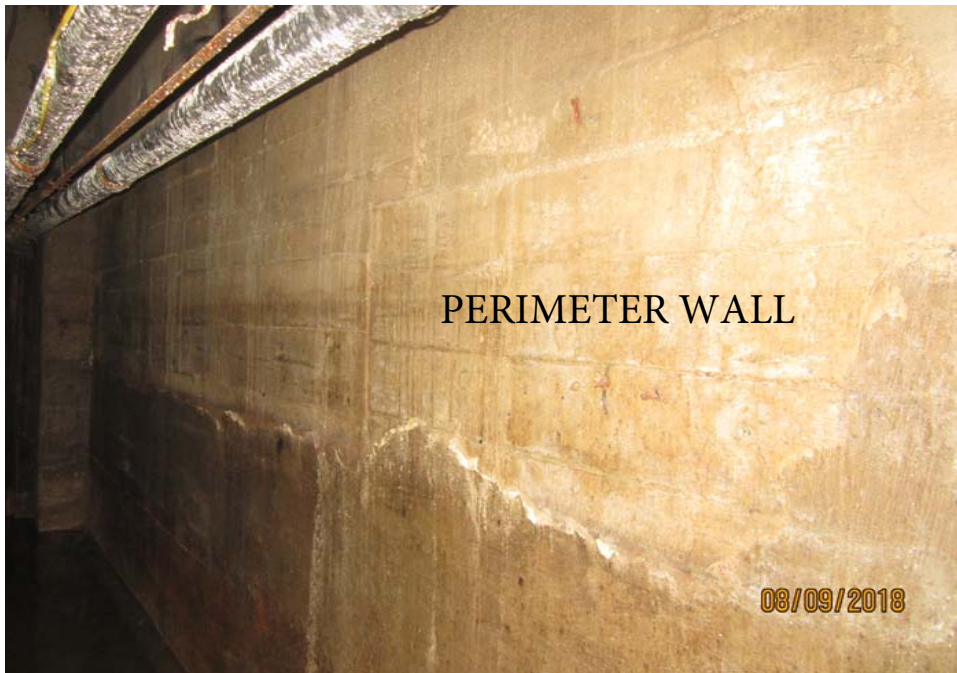
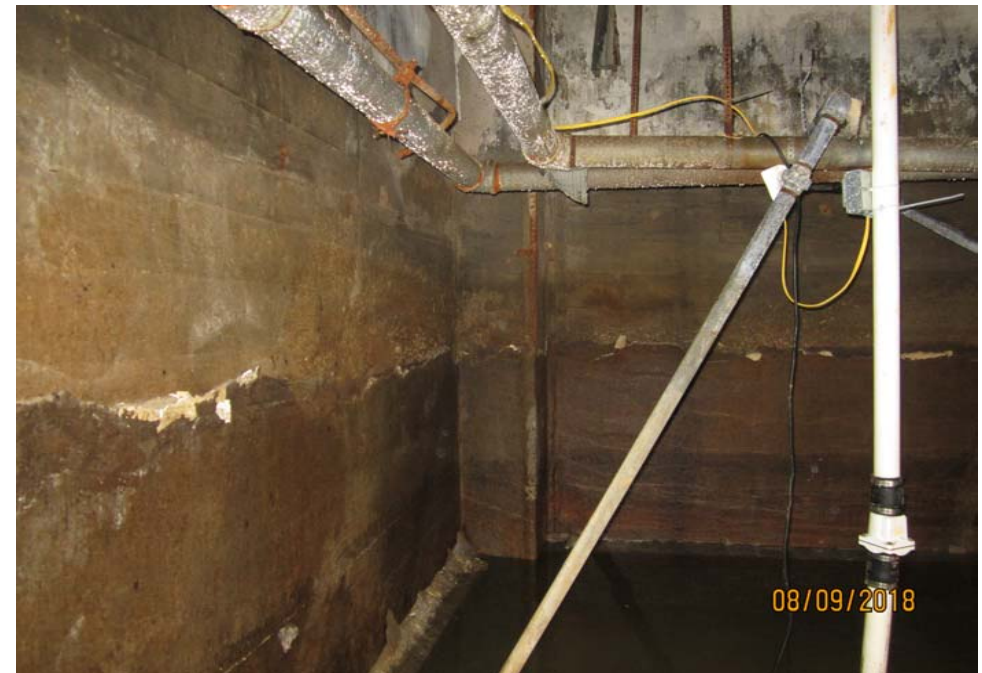
**A.5 Basement:** The building has a full basement with perimeter concrete walls and exterior steel columns embedded in concrete. The walls were in good condition with no obvious signs of cave-ins, spalling, exposed corroded steel, and cracking. The basement floor was concrete slab-on-grade and in walkable condition. The basement ceiling (underside of 1<sup>st</sup> floor) clay tiles and concrete encased steel beams were visible and in good condition. The interior columns were observed at many locations and were covered with concrete encasement. In general, among all the debris, we could not find any signs of structural distress, loose concrete, corroded steel, sagging floors, etc. The observed conditions in basement are photographically shown in Appendix B. pages 9 and 10.

BASEMENT PERIMETER WALLS AND CONCRETE ENCASED INTERIOR COLUMNS . NOTE GOOD  
CONDITION OF WALLS AND COLUMNS.
