# STRUCTURAL ASSESSMENT REPORT

## **WASHINGTON PARK NATIONAL BANK**

6300 South Cottage Grove Ave.  
Chicago, Illinois 60637

**RE:** Structural Assessment Report for  
**Washington Park National Bank Building**  
6300 S. Cottage Grove  
Chicago, Illinois, 60637  
Probe Project No: 2018.529

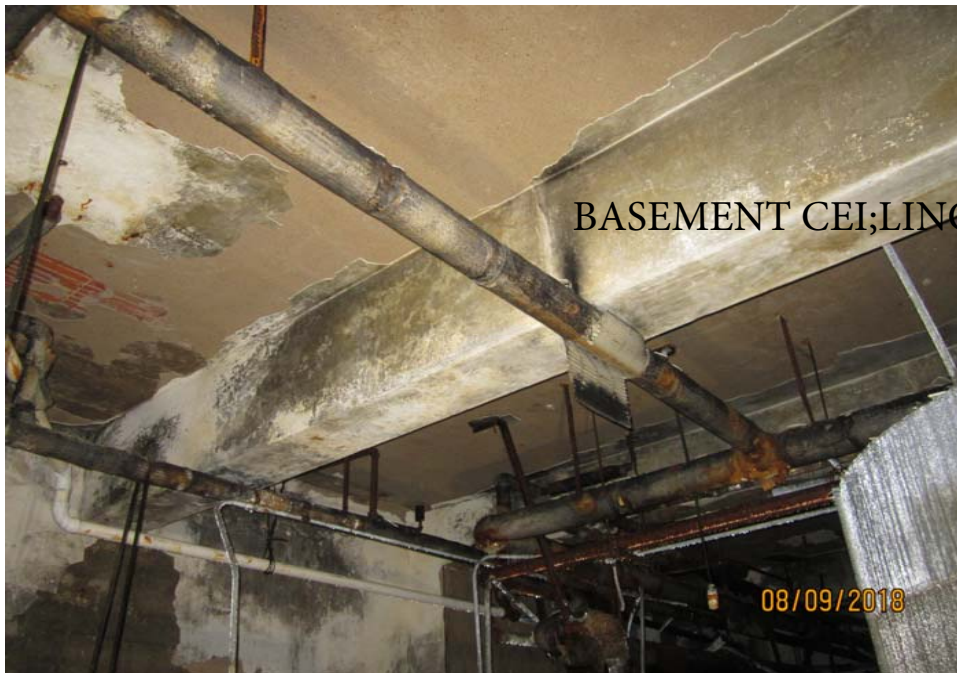
BASEMENT CEILING

**A.5 Basement:** The building has a full basement with perimeter concrete walls and exterior steel columns embedded in concrete. The walls were in good condition with no obvious signs of cave-ins, spalling, exposed corroded steel, and cracking. The basement floor was concrete slab-on-grade and in walkable condition. The basement ceiling (underside of 1<sup>st</sup> floor) clay tiles and concrete encased steel beams were visible and in good condition. The interior columns were observed at many locations and were covered with concrete encasement. In general, among all the debris, we could not find any signs of structural distress, loose concrete, corroded steel, sagging floors, etc. The observed conditions in basement are photographically shown in Appendix B. pages 9 and 10.
